Phase I Environmental Site Assessment

OREGON PINE

**Lot 300 in Section 22 of T. 13 S., R. 31 E.
John Day, OR 97845**

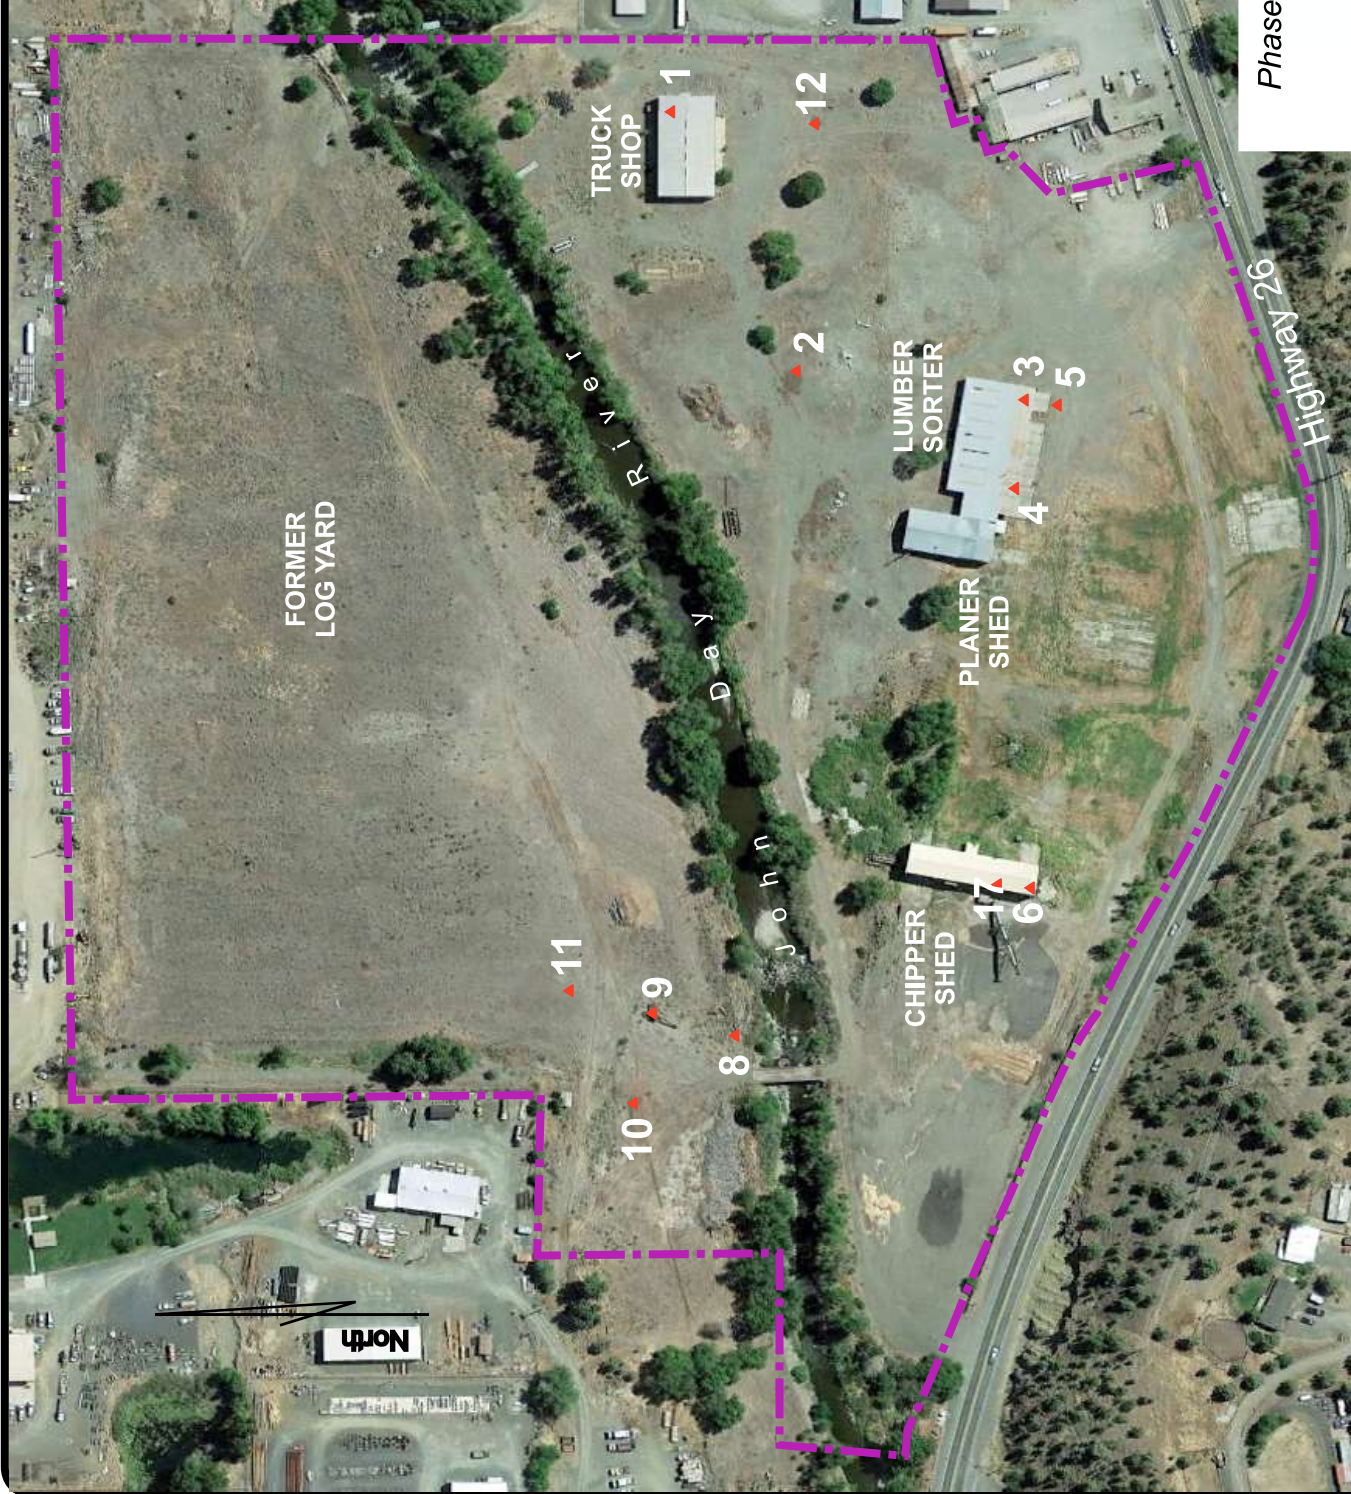
Areas of Concern

- Mark Yinger identified the following environmental conditions during the course of this assessment.
 1. Mechanic's Pit Sump: The mechanic's pit in the Truck Shop building has a sump. The sump is filled with oily sludge. The sump may be connected to a drain pipe or simply drain into the subsurface. Petroleum and solvents may have been released to the environment via the sump.

2. Hydraulic Oil Tanks: In the Chipper Shed there are two hydraulic tanks, a 300-gallon tank and a 500-gallon tank. The 300-gallon tank is 90 percent full. There is no sign of leakage. The 500-gallon tank is approximately 50 percent full. There is heavy oil staining on the steel leak containment pan beneath this tank and pump. There is no secondary containment for these two tanks. There is also an open 5-gallon pail of oil on the leak containment pan. The two tanks and the 5-gallon pail of oil pose a material threat of a release to the environment.

3. Reddish-orange stained soil adjacent to the southeast corner of the concrete pad on the south side of the lumber sorter shed. Few plants grow in the area of the red-orange stained soil. The staining is not surficial. The staining may be ink used to stamp finished lumber products. The pigment may contain hazardous metals.

4. Oil stained kill zone: Approximately 200 feet west-southwest of the Truck Shop is a 15-foot by 15-foot, oil stained area in which no plants grow. The soil has a strong petroleum odor. There had been a utility pole at this location with two electrical transformers on it as recently as 2013. Oil from the transformers may have been released at this location.

5. Heavy oil stains:
 - a. Approximately 100-feet south of the southeast corner of the Truck Shop is a recent, heavy oil stain.
 - b. Patches of oil staining were observed on the ground below the Link-Belt log loader, the Prentice log loader, the Petibone Multilkrane, and 8 feet east of the Caterpillar log loader on the north side of the river.

- 1...Mechanic's pit sump
- 2...15' x 15' patch of petroleum contaminated soil
- 3...Petroleum contaminated soil east end of lumber sorter
- 4...Petroleum contaminated soil west end of lumber sorter
- 5...Red staining on ground
- 6...300 gal. tank hydraulic oil
- 7...500 gal. tank hydraulic oil
- 8...Heavy oil stain leaked from equipment recently removed
- 9...Heavy oil stain beneath log loader
- 10...Heavy oil stain beneath mobile crane
- 11...Heavy oil stain beneath log loader
- 12...Heavy, recent oil stain

1. The sump in the floor of the mechanic’s pit in the Truck Shop needs to be cleaned and investigated to determine where it drains to. The sump should be seal with concrete after cleaning. Several borings should be made through the floor of the shop to test for impact to soil and groundwater.
2. The hydraulic oil in the tanks at the Chipper Shed should be drained and the oil removed from the subject property. If it remains on the subject property in drums the drums should be in secondary containment. The open 5-gallon pale of oil should be removed from the subject property or placed in secure secondary containment.
3. A sample of the reddish-orange stained soil should be tested for hazardous metals.

4. The vegetation kill zone with an oil odor located southwest of the truck shop should be sampled and the soil tested for petroleum and polychlorinated biphenyls (PCBs).
5. The recent oil spills should be cleaned up by excavation and disposal at the Crook County Landfill. The extent of the cleanup excavations should be based on field screening. A composite sample of the waste should be collected to characterize the waste so that it can be disposed at the landfill.
6. The containers listed above in item six should be removed from the subject property or placed in secondary containment.
