Memorandum

Subject: Site Walk Findings – October 29,2020
K/J 2076017.00

Kennedy Jenks (KJ) staff (Dean Wood, Michael Humm, Amanda Mesick) completed a site tour of the John Day Wastewater treatment Plant (WWTP) on 29 October 2020. The purpose of the visit was to obtain site data and information needed to complete an alternative evaluation as part of the scope of work contracted under Flagline Engineering. This evaluation is expected to include performance and cost based comparisons of 3 treatment process alternatives, including one option which evaluates the ability to rehabilitate the existing WWTF. The objective of the evaluation is to determine the best cost solution meeting the City's discharge permit requirements. Each alternative must provide the same level of service and operational life expectancy across each alternative.

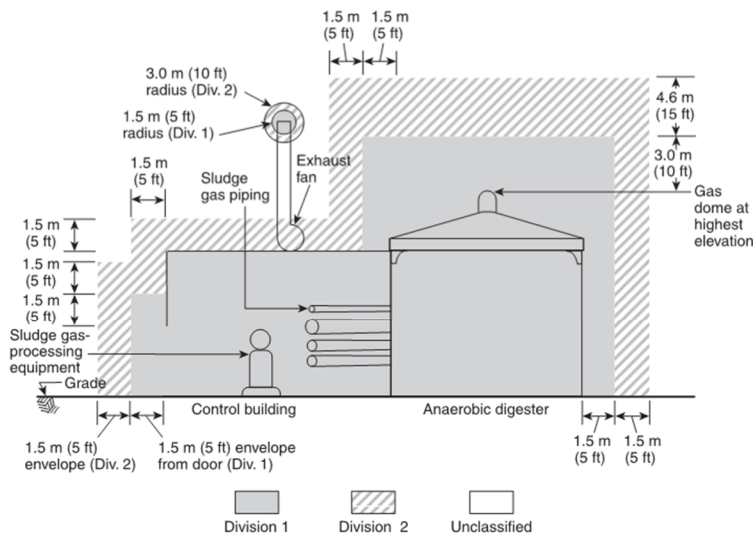
FIGURE A.6.2(e) Anaerobic Digester Control Building Containing Sludge Gas-Processing Equipment not Physically Separated and Using Ventilation Method (A); Illustration of Table 6.2.2(a), Row 17.

Based on the site walk and review of as-built information, the existing control building layout triggers several classification criteria with NFPA 820: influent pumping (Table 4.2.2 Row 17), sludge pumping (Table 6.2.2(a) row 9), and anaerobic digester gas handling (piping) (Table 6.2.2(a) Row 17). Each of these criteria trigger the need for ventilation requirements. Without nameplate data of the ventilation system, we are unable to determine exact classification, however, if less than 12 air changes per hour as determined by the presence of gas handling equipment, the entire building space is classified as Class 1 Division 1. If air changes exceed 12 air changes per hour, the building space is classified as Class 1 Division 2, except within 5 feet of the digester walls. In addition to ventilation criteria, the standard also prescribes air monitoring and alarming.

Figure A.6.2(e) is an illustration of Row 17 and the presence of sludge gas piping and gas processing equipment as found in the control building during our site walk.

Ventilation improvements may be able to bring the existing space to a Class 1 Division 2 rating, however Class 1 Division 1 space will remain within 5' of the existing digesters. Replacement of existing motors and equipment is pervasive and requires all rated equipment to be installed. Additionally, a new electrical room outside the classification space would be required for the motor control center.

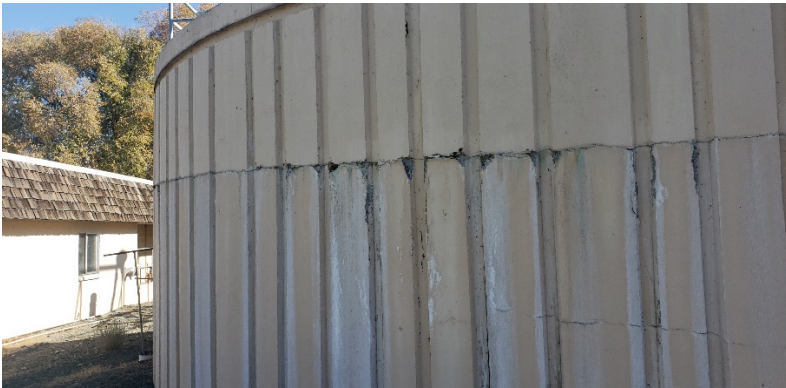
Concrete basins including both the primary clarifier and the secondary clarifier, and the trickling filter flow splitting structure were found to have visible cracking with active seepage. (Photos 1-2). The cracking appeared to be uniform across the basins and may be indicative of a poor cold joint developed during initial concrete placement. Repair of this type of condition in this age of concrete is difficult and can have limited success.

Photo 1 – Primary Clarifier – concrete cracking/weeping

Resulting approach to alternative evaluation: the ability to reuse existing concrete tankage is very limited. The active weeping across many of the structures is concerning and indicates the basins are at or near the useful life of the structures. Repair methods, particularly on the clarifiers with the fluted architectural exterior are going to be very difficult and costly and even with repair, the crack will never be fully restored to a remaining life similar to what a new concrete structure would provide. The findings suggest if the existing site is to be used for continued WWTP operations, new basins would need to be constructed.

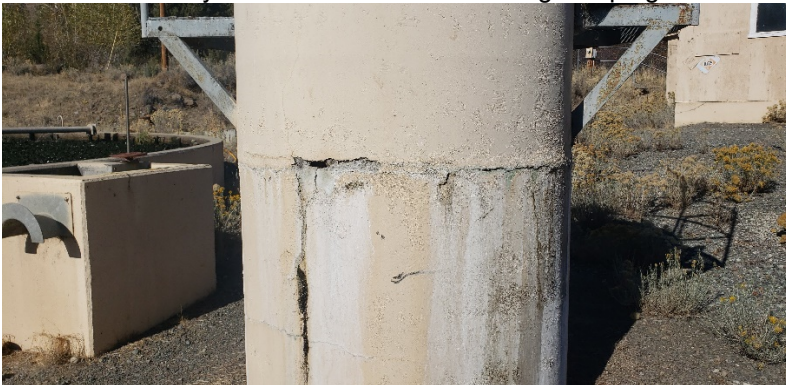
Photo 2 – Trickling Filter flow splitting structure – concrete cracking/weeping

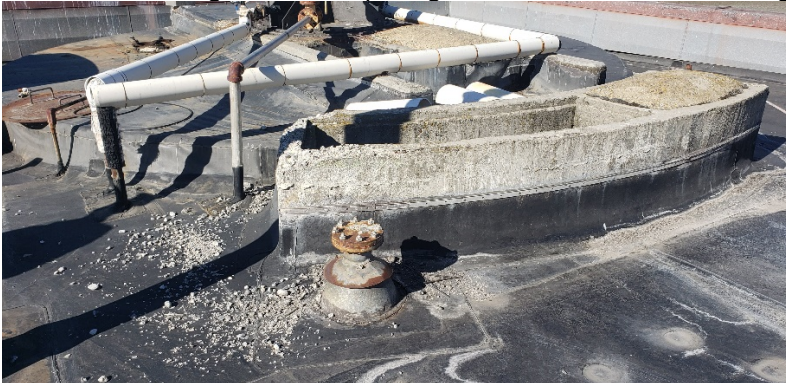
The primary (heated) digester and secondary (unheated) digester were both found to be in near failing condition. The primary digester has significant concrete deterioration at the roof and digested sludge overflow vault. (Photo 3). Digester lid equipment, including flame resistors, pressure relief valves, and gas handling piping was corroded and may provide limited functionality. An access port in the primary digester lid was significantly corroded and had been dislodged from the digester roof (Photo 4). This penetration allows passive venting of digester gas and creates a significant safety concern. The secondary digester lid is a floating steel lid. Digester contents had overtopped the floating lid and the lid remains stuck and unable to travel. (Photo 5)

Photo 3 - Primary Digester roof – concrete corrosion

Primary and secondary digester roof replacement is needed. Operations staff indicate the primary digester mixer has significant bearing issues and there is no known condition assessment of either digester's interiors. The ability to reuse the digesters is unknown, but based on roof top condition and aging and leaking concrete structures onsite, the ability to rehabilitate the digester is unlikely.

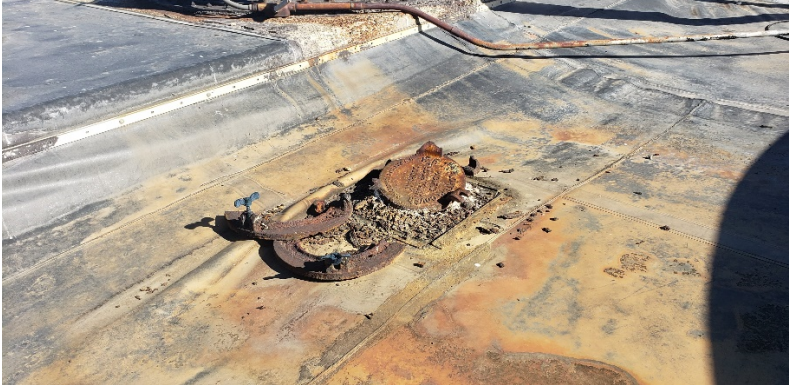
Photo 4 - Primary Digester roof – penetration failure – passive venting

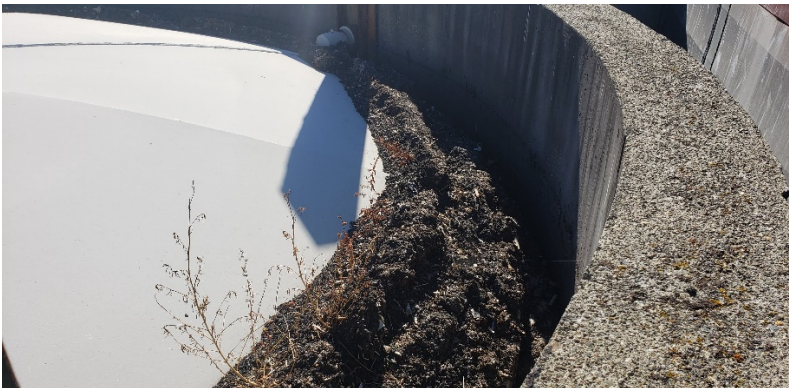
Photo 5 - Secondary Digester roof – failed floating lid
