## **Appendix A. Condition Assessment**

### **Gleason Pool Background**

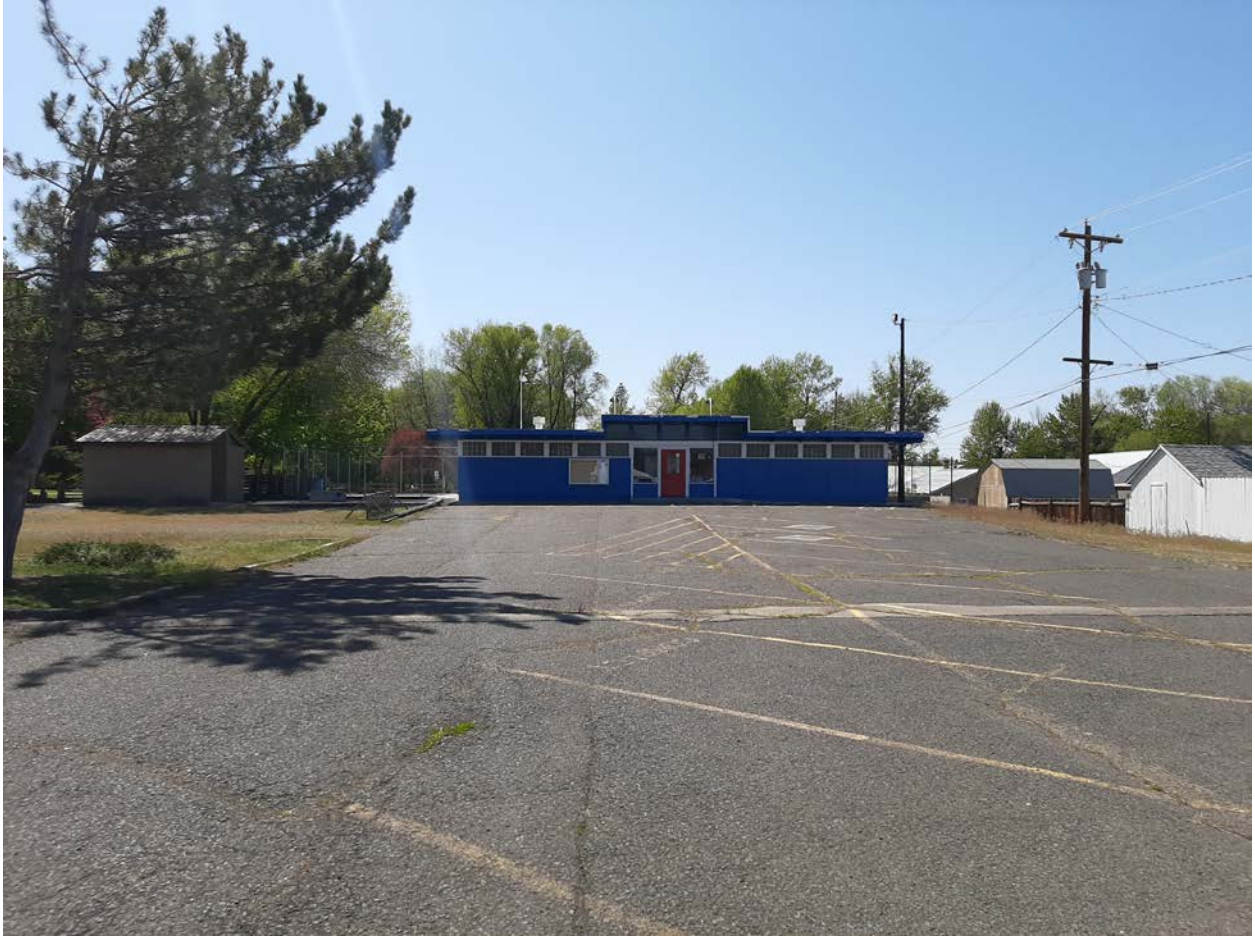
- Pool is not suited for seniors or handicapped individuals.
- Parking lot is inadequate in size, with only 16 spaces and 2 ADA-parking spots, parking areas are deteriorating to gravel and need to be replaced.

*Figure 1. Gleason pool parking lot, front perspective*

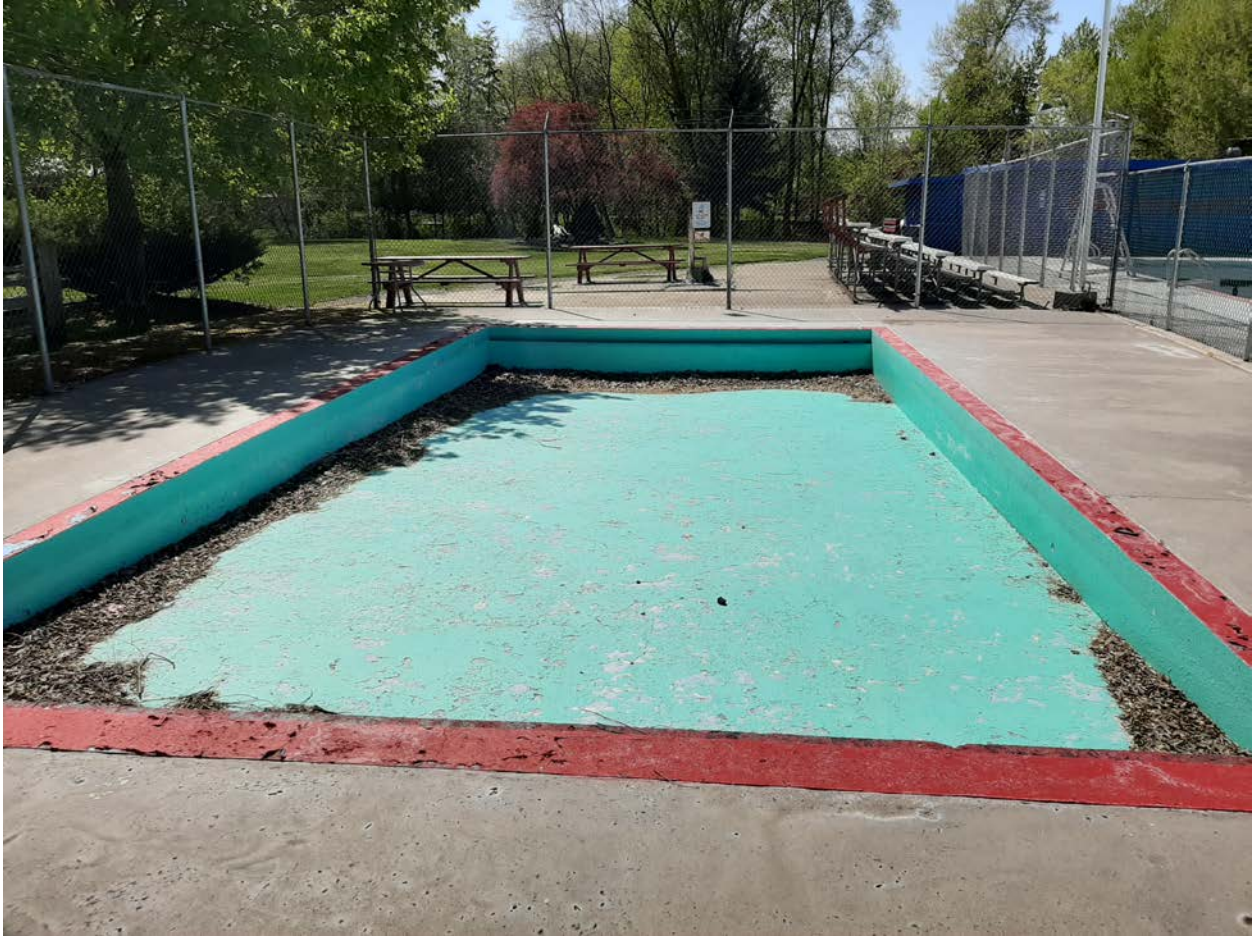
*Figure 2. Unheated, uninsulated wading pool south of the main pool*

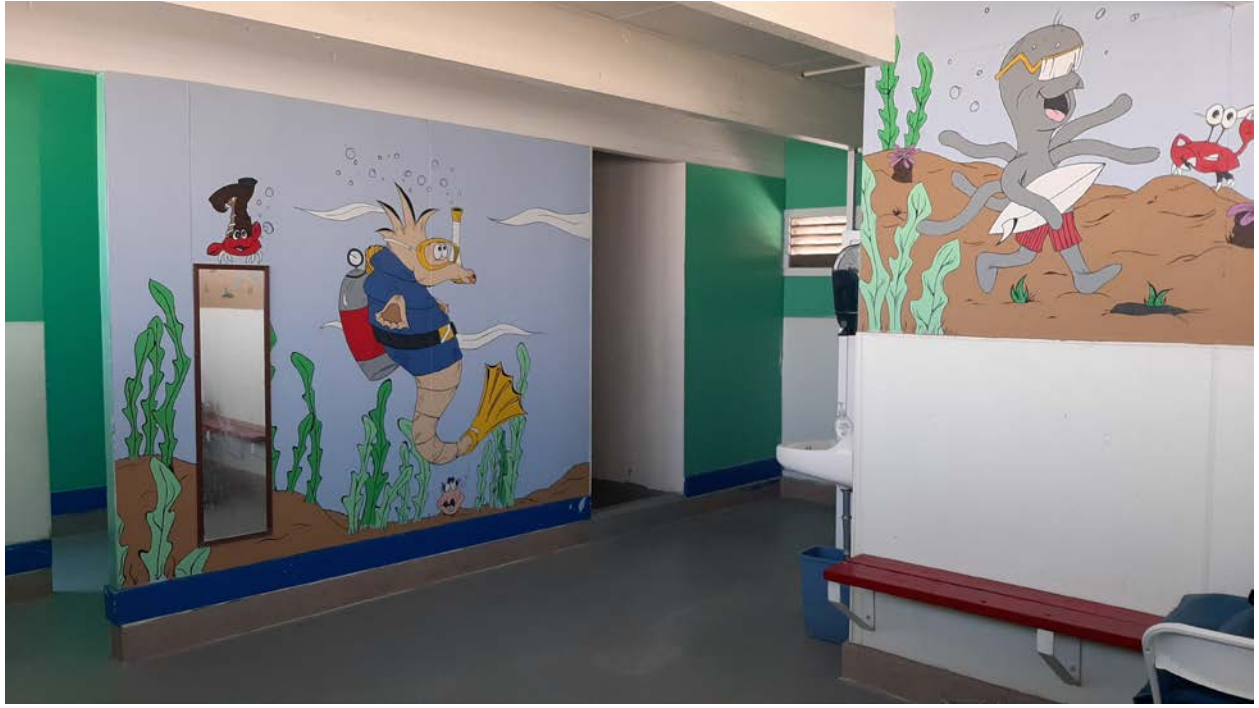
- Locker rooms are undersized and restrooms are inadequate for swim meets and large group events.
- Gleason is a five-lane trapezoidal pool, which is non-standard for competition events that are typically held in six-lane rectangular pools.

Figure 6. Boys locker room

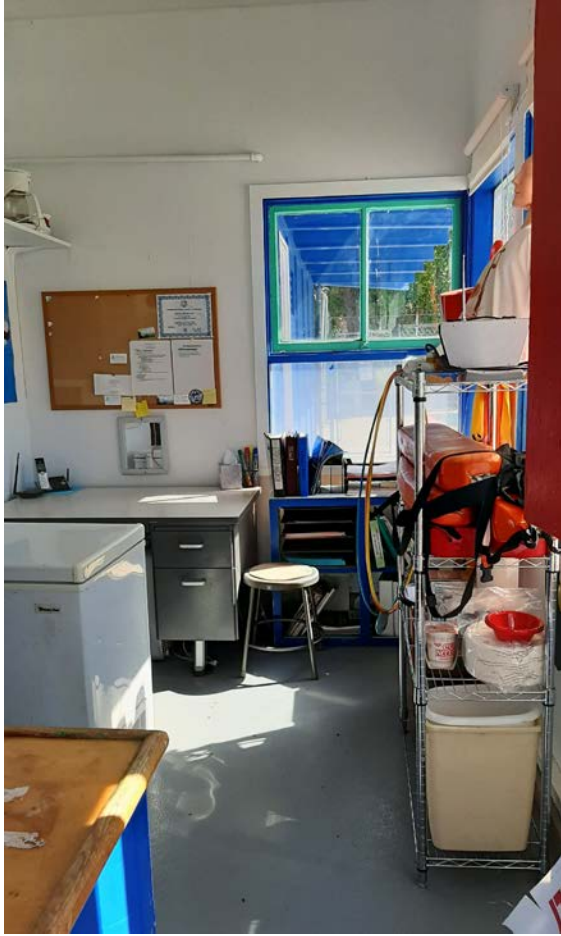
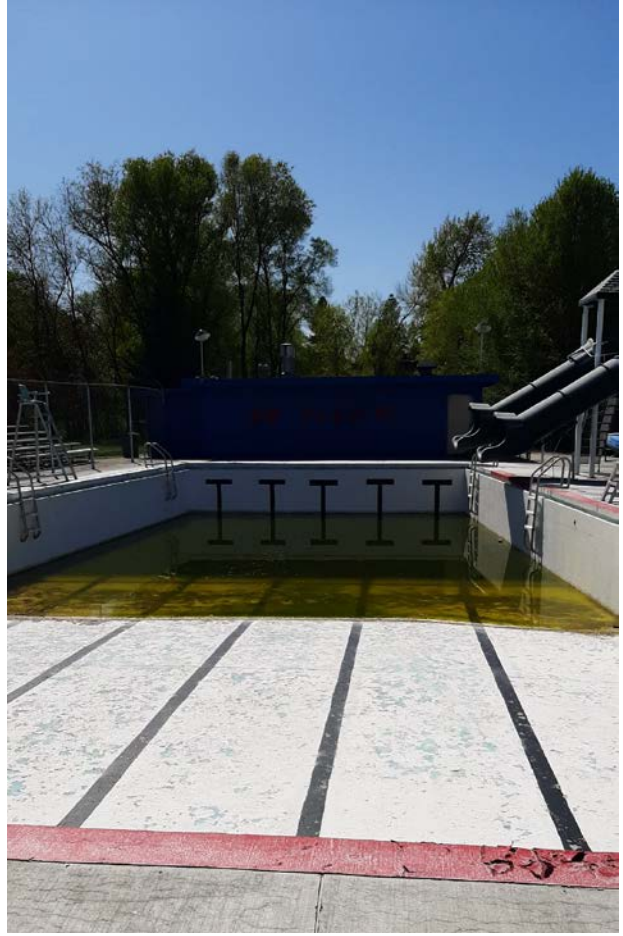
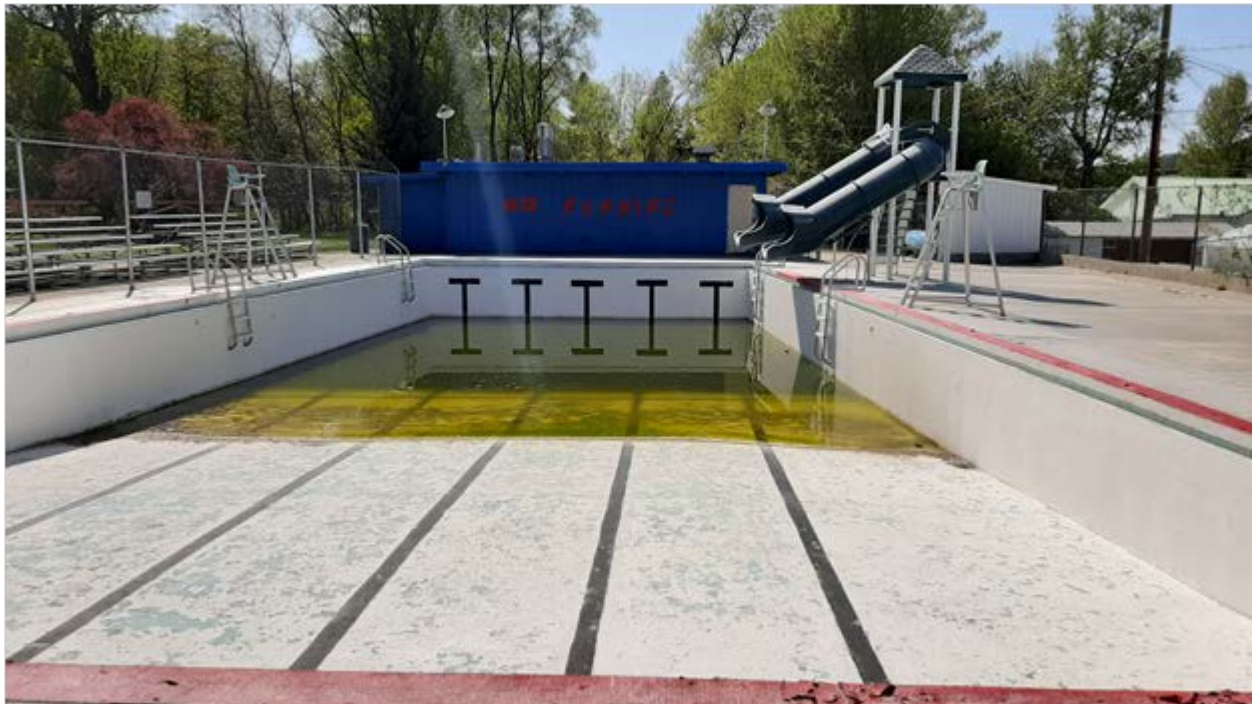
- Pool tunnels under constant repair.
- Pool surface deteriorating - wastes money to continue to paint because the paint will not adhere to the concrete. The concrete pool surface is eroded; the District works on it every year but the last two years has been a complete waste of time and money. The new paint has not lasted more than a couple weeks.

Figure 7. Shared office space/lifeguard area (top left), pool and deck edging showing visible wear/erosion (top right, bottom)

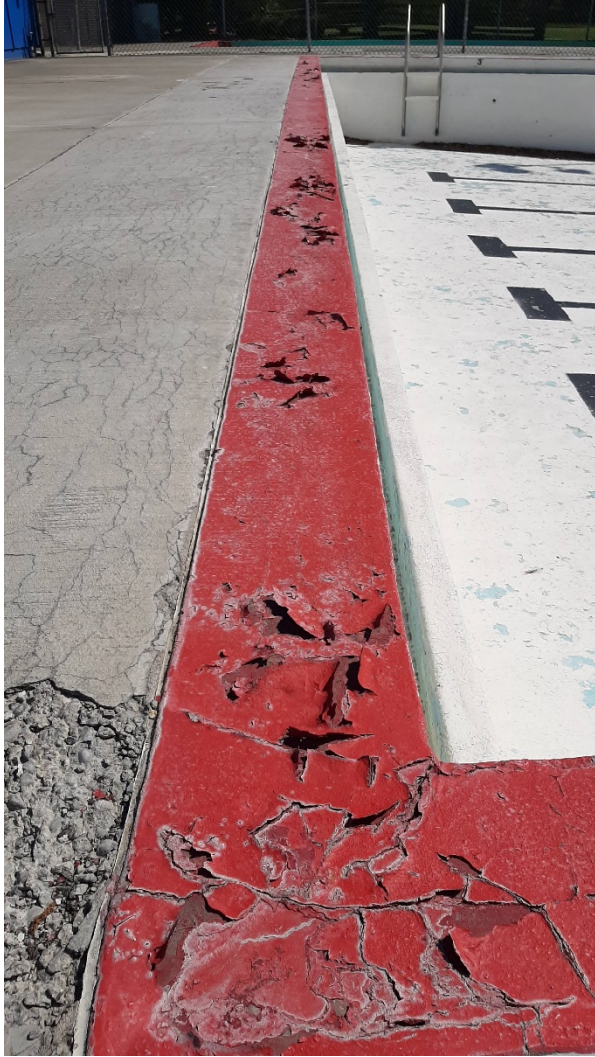
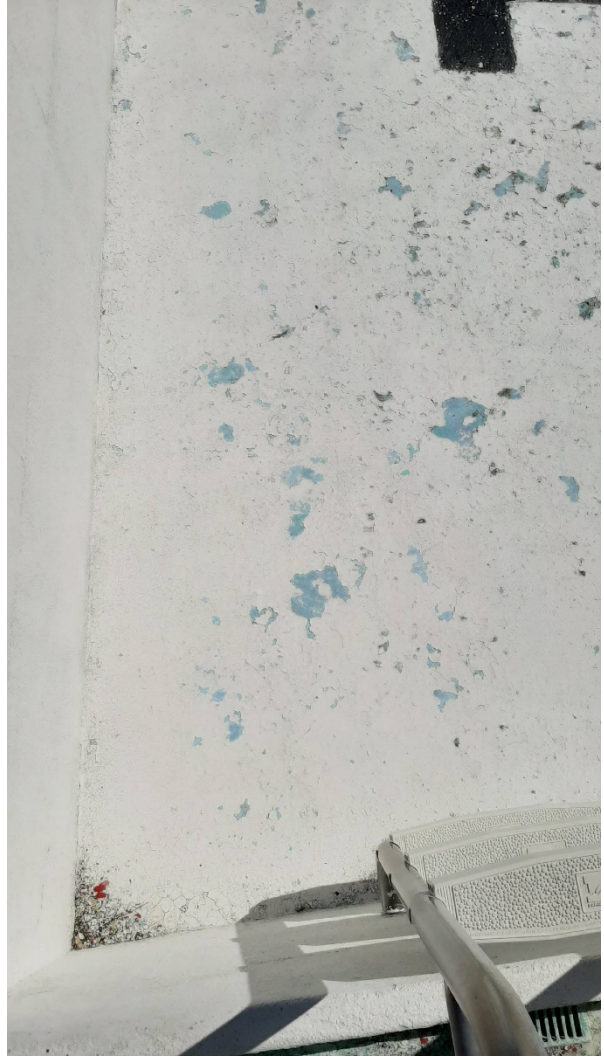
*Figure 8. Eroding and chipped concrete prevents paint adherence (left); eroded concrete within pool (right)*

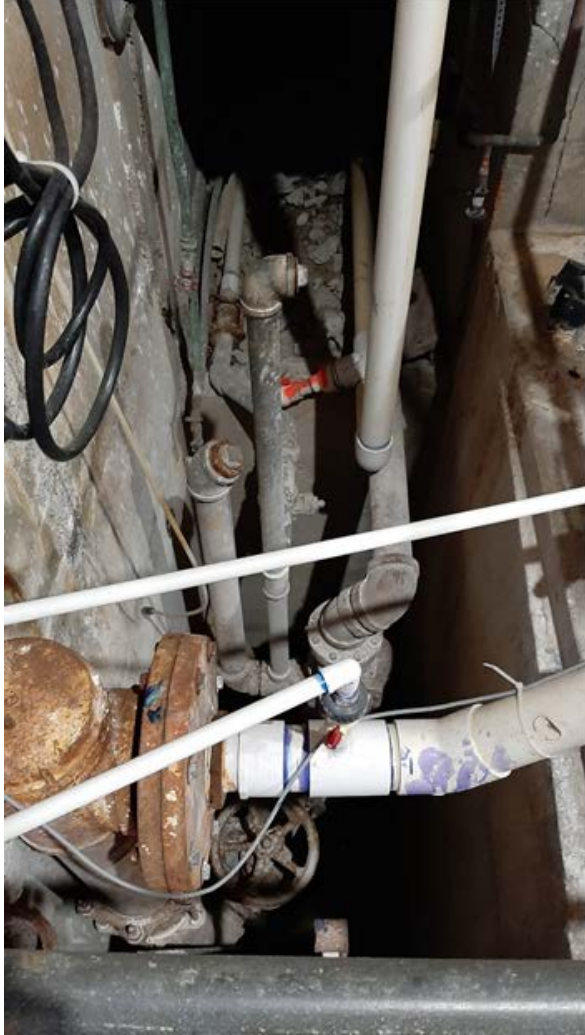
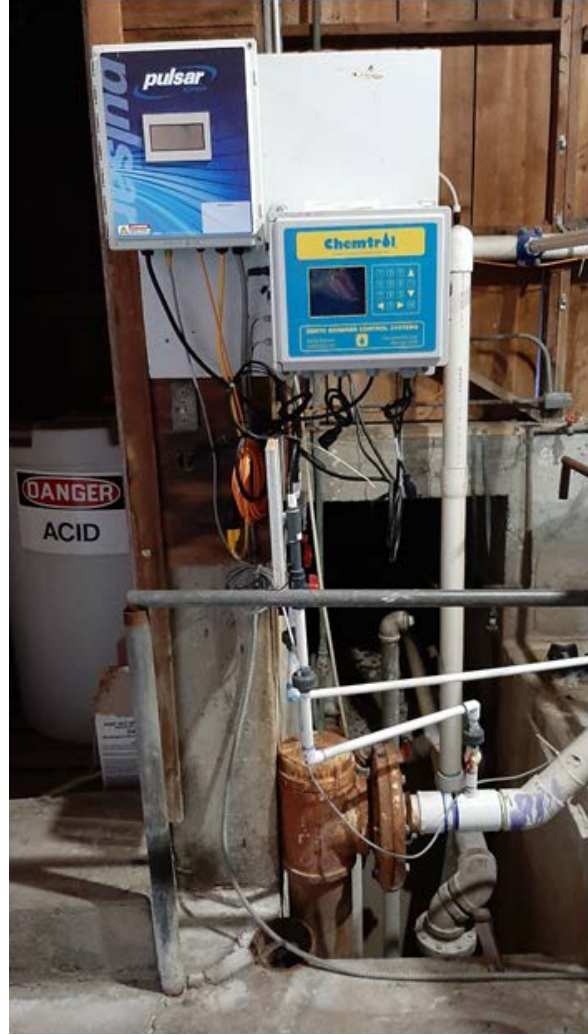
- Replaced the roof on both the boiler room and the office locker rooms due to significant dry rot left in both areas.
- The pool deck was refurbished, along with the security fencing.
- In 2015, Iron Triangle worked on the galvanized pipe that feeds the office shower area and goes directly under the office area, bypassing the old piping in this area.
- The back windows in the office were replaced a few years ago, dry rot was observed on all of the surfaces exposed within the pool house as part of this project.
- The chlorinator was replaced a couple of years ago and is currently not working, again.

Figure 10. Corroded galvanized pipe and casings (left); chlorination system (right)

To preserve Gleason Pool for an additional 10-15 years, the electrical components would need to be completely overhauled in both the pool house and pump house. It is uncertain how long the boilers could be maintained – one is currently inoperable. Both would need to be replaced. Galvanized piping servicing the pool may need to be replaced to extend its life, which would require removing significant portions of the deck area and replacing that portion of the pool at a minimum. Neither the pool nor the building and parking areas/entrances meet current ADA-accessibility standards.

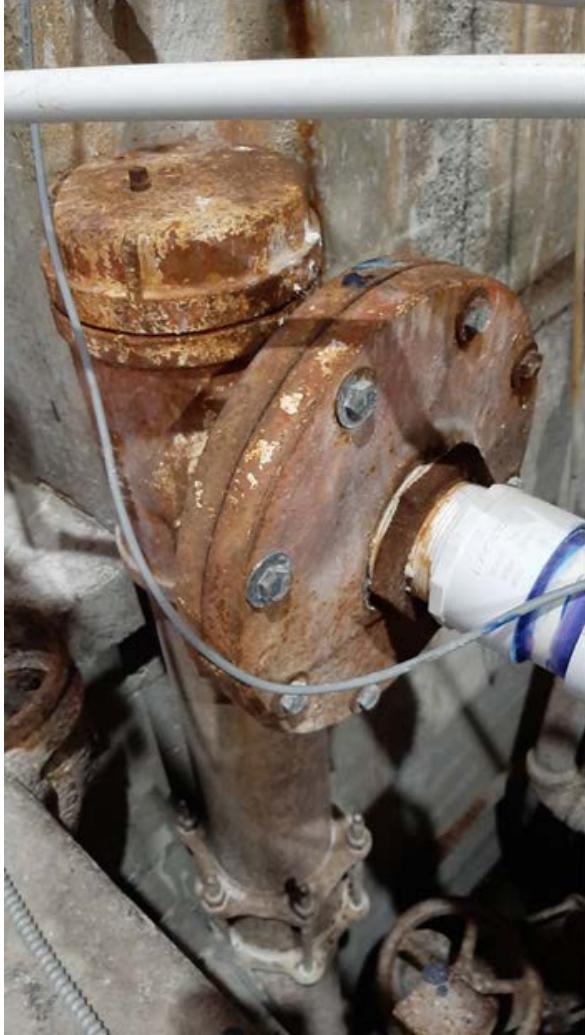
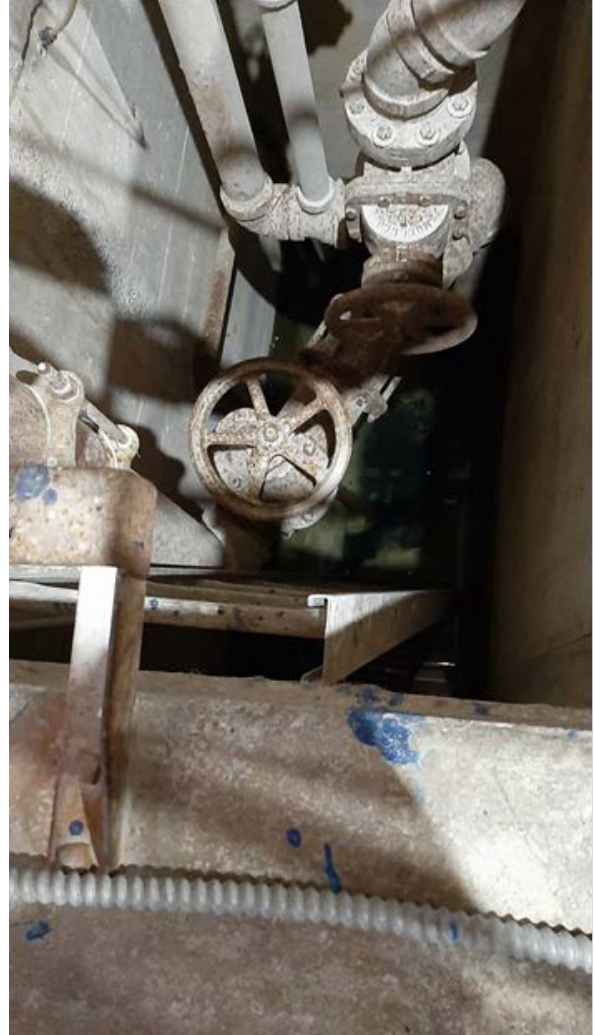
*Figure 11. Galvanized pipe and casings (closeup)*

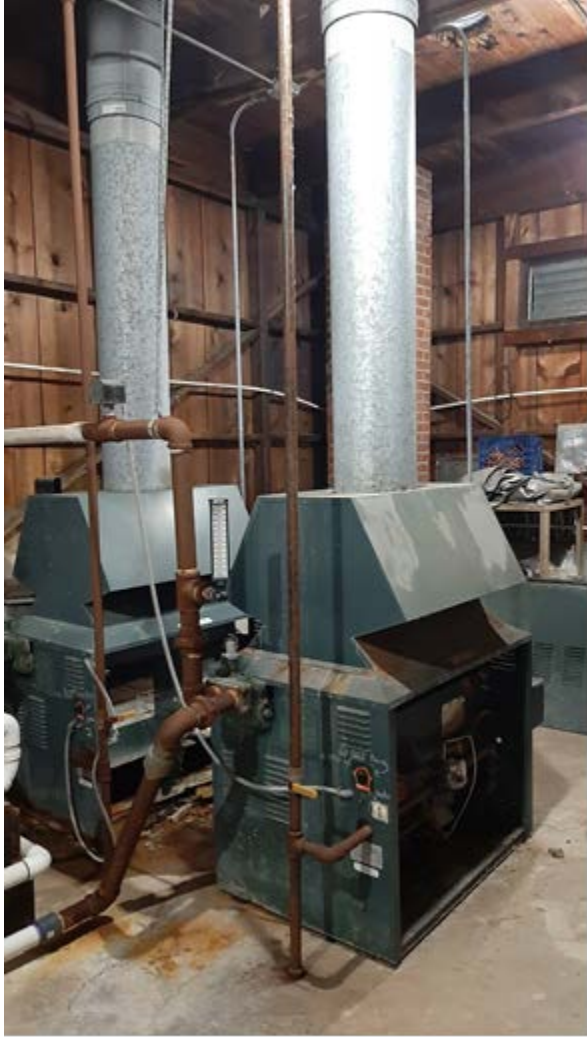
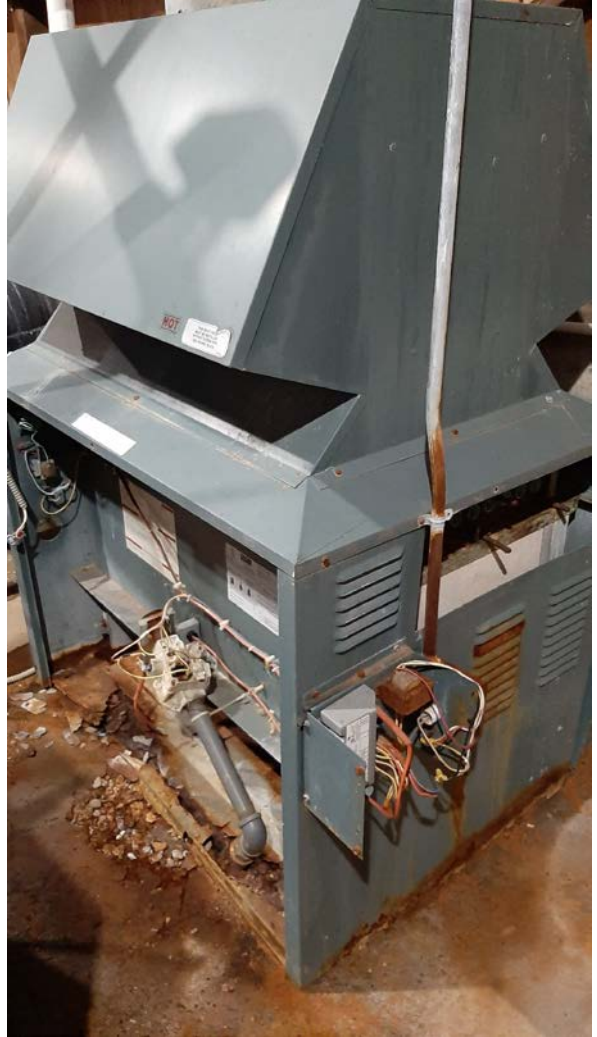
*Figure 14. Pool boilers installed in 1990 (only one remains operable)*
