# CITY OF JOHN DAY SW 4<sup>TH</sup> AVENUE FLOOD REPAIR

SEPTEMBER 27, 2022

# 2019 Flood Damage

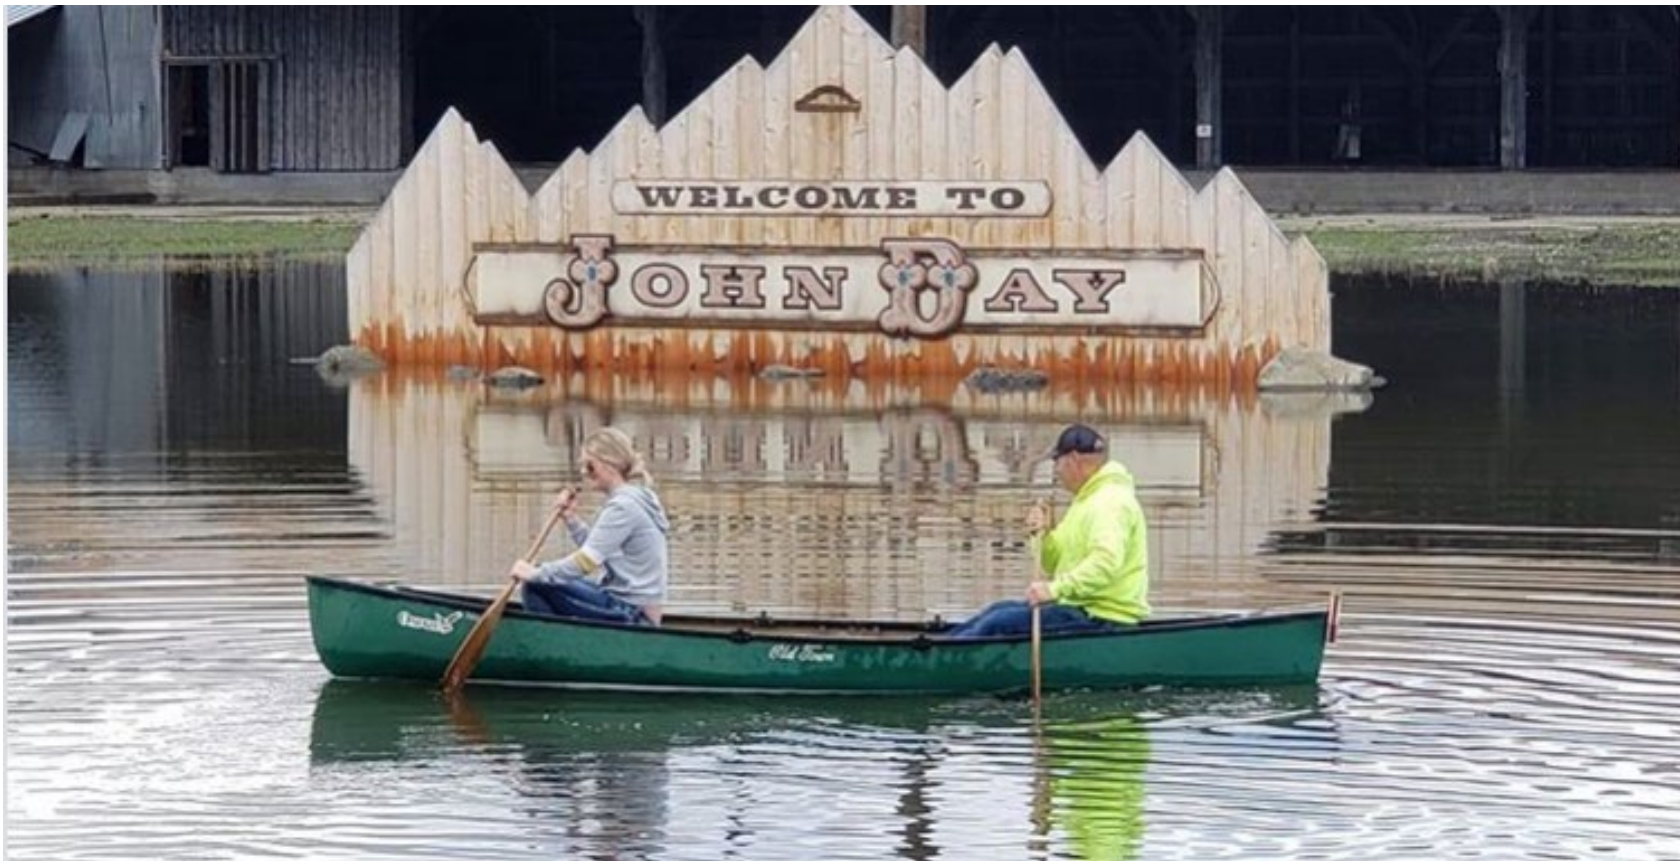
- Undermined SW 4<sup>th</sup> Avenue road base
- Resulted in 3-foot crack in pavement from road base
- Total loss of native vegetation in the creek
- Approx. \$1.5M in damage to John Day infrastructure

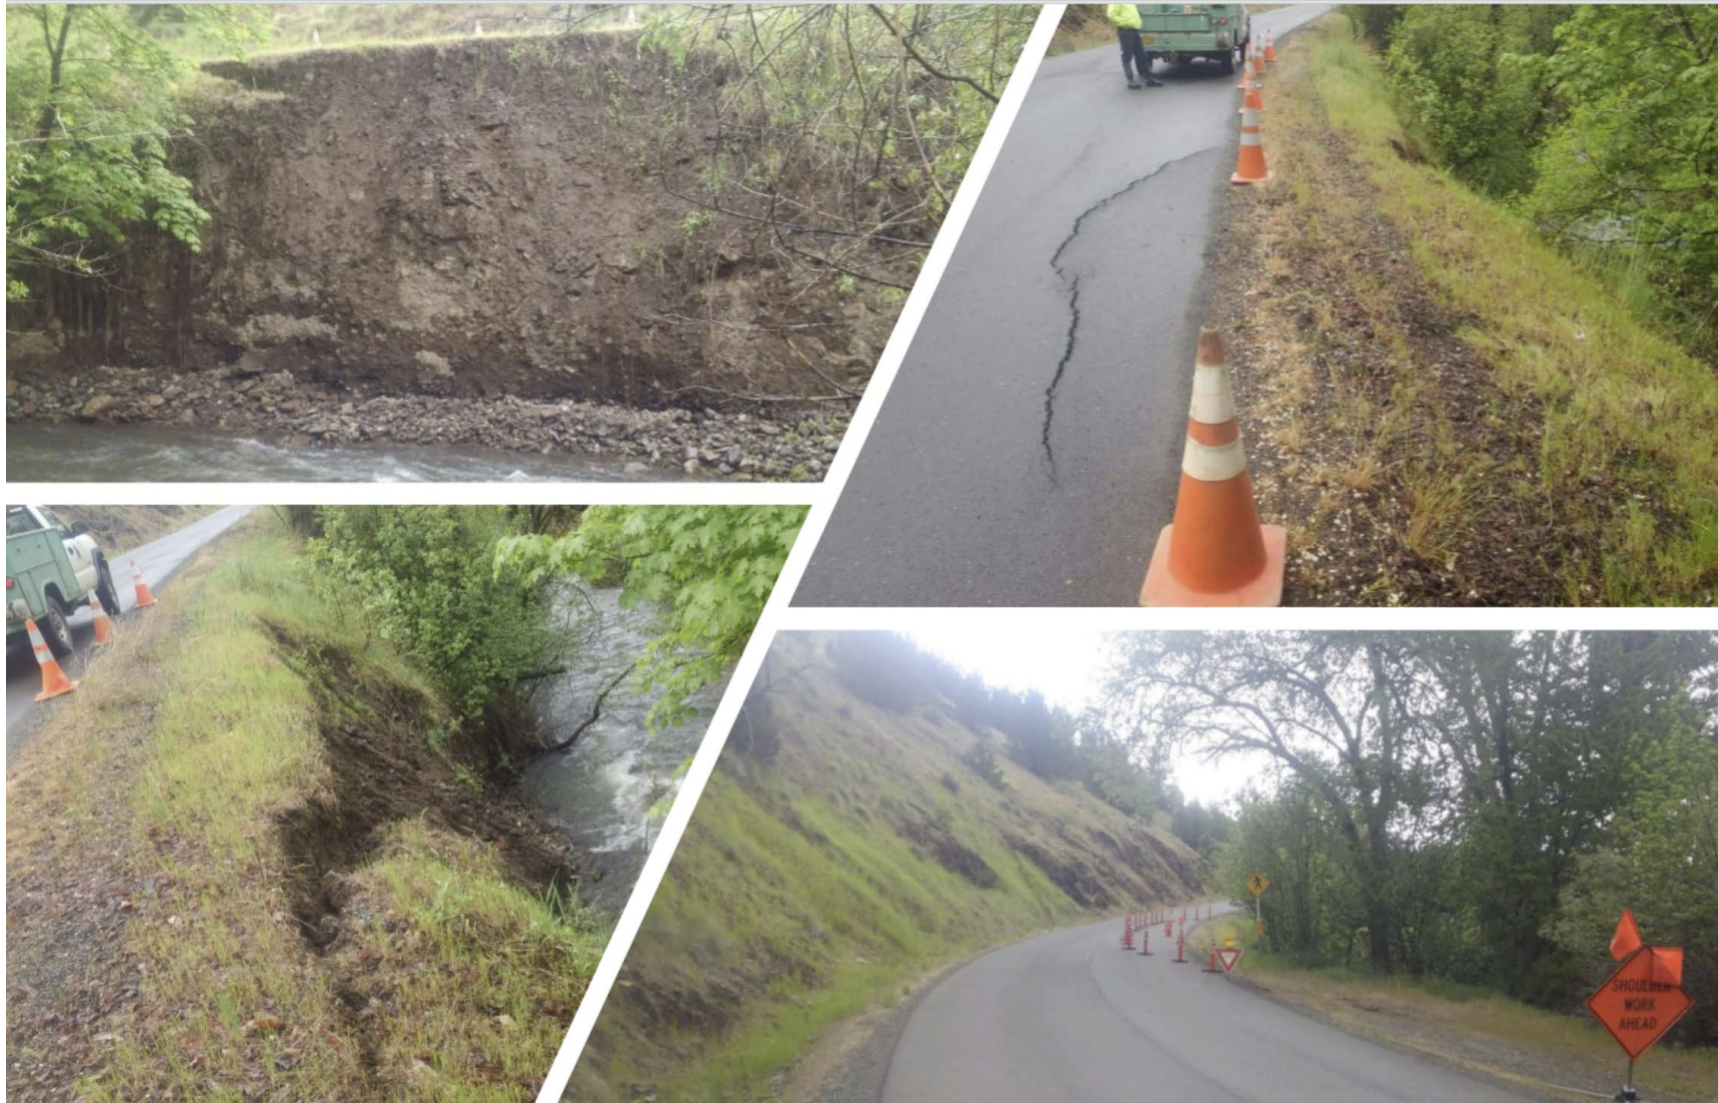
# Flood Damage to SW 4<sup>th</sup> Avenue

Exposed 23-foot vertical cut to the creek bed, single-lane closure from April 2019 through October 2022 (3.5 years)
