Carlson Geotechnical

Field Observation Report

CGT Project No.: G2005320
Permit No.: N/A

Project:	Elm Street Property	Date:	June 4, 2020
Address:	SE Elm Street & Hillcrest Drive, Oregon	Report Date:	July 24, 2020
Purpose:	Perform Geotechnical Reconnaissance	Staff:	Brad Wilcox, P.E., G.E.
Area of Site:	Entire Site	Weather:	Mostly Sunny, ~75°F
Requested By:	Nicholas Green of City of John Day (client)	Arrival/Departure:	10:00 a.m. / 11:05 a.m.

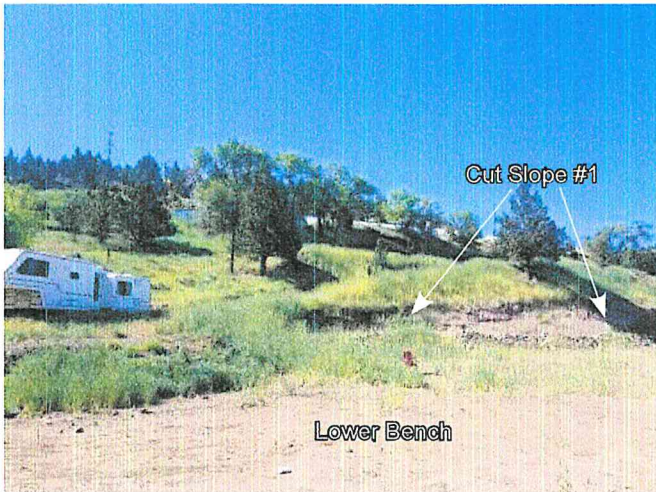
Photograph 1: Looking south from a point near the NE corner of the site.

- The lower bench was bounded by the existing boulder retaining wall (described above) on its north and west sides, an apparent cut slope on its south side, and offsite property and the public street intersection on its east side. This bench appeared to have been created by a combination of cuts and fills, with fills present along its north margin (near the referenced wall) and cuts apparent at its south margin. The lower bench was surfaced with soils and sparse vegetation (grasses). Photographs 1 through 4 and 9 on the attached Figure 1 show conditions within the lower bench.

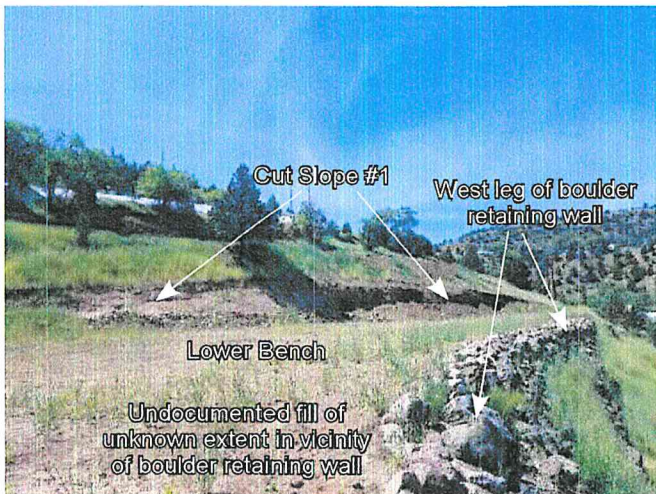
Photograph 3: Looking southwest from a point near the corner of the existing boulder retaining wall.

- Boulder Retaining Wall:** I observed a boulder retaining wall was present along the north and northwest margins of the site. Photographs 3 and 5 through 8 on the attached Figure 1 show conditions of the retaining wall.

- The cut slope along the south margin of the lower bench, designated as Cut Slope #1, exhibited relatively steep gradients, visually estimated to range from about 1H:1V to ¼H:1V. The slope was visually estimated up to about 8 feet in height. The cut slope material consisted predominantly of fractured basalt bedrock with rooted soils near the top of the cut. In a few locations, there were loose materials at the base of the cut (apparent talus). Photographs 3 and 9 on the attached Figure 1 show conditions along this cut slope.

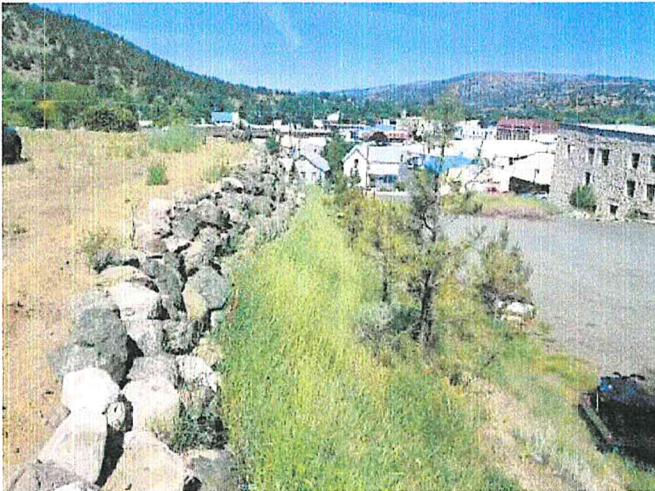
Photograph 5: Looking west along east leg of boulder retaining wall.

- The retaining wall was up to about 18 feet (+/-) in height, consisted of variably sized, subangular basalt boulders, and exhibited a relatively level soil-covered backslope. The size of the boulders ranged from about 1 to 5 feet in diameter (approximate), with the diameter generally decreasing towards its top. No tension cracks were observed within the backfill area along the top of the retaining wall.

- The retaining wall exhibited a visually-estimated batter ranging from about ½H:1V (horizontal:vertical) to 1H:1V, with shallower batter present within the central, taller portion of the wall alignment.

- **Boulder Retaining Wall:** During today's visit, I did not see any indicators of local or global instability of the subject retaining wall. With that said, I indicated that the long-term performance of the boulder retaining wall could not be determined unless geotechnical investigation and analyses were performed. Based principally on visual inspection and experience with designing boulder retaining walls, I indicated that a likely outcome of such investigation and analyses, if performed, would be that stability factors would likely below industry standards. This judgment is based on the height of the retaining wall, apparent lack of embedment of the lowest row of boulders into the slope, less than ideal placement of boulders (i.e. the boulders exhibited variable contact between them and in some cases, exhibited sizeable voids), and other factors. Reliance on the retaining wall and/or its associated backfill for structural support of new buildings, pavements, or other structural features, if such development is considered, is not recommended unless a geotechnical investigation is conducted by a geotechnical engineer or certified engineering geologist.

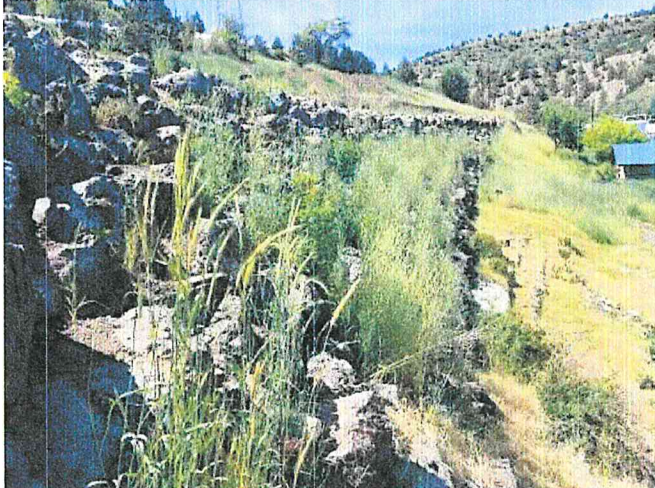
Photograph 7: Looking southwest along base of west leg of boulder retaining wall.

- Along the west leg of the retaining wall, soil and sparse vegetation (grasses) were present in between the boulders. No cobbles were present in between the boulders, resulting in sizeable voids in between them.

- Below (downslope of) the retaining wall, the site was predominantly grass-covered and descended in the same general direction of the wall batter. No active erosion or other signs of instability was noted along the base of the retaining wall.

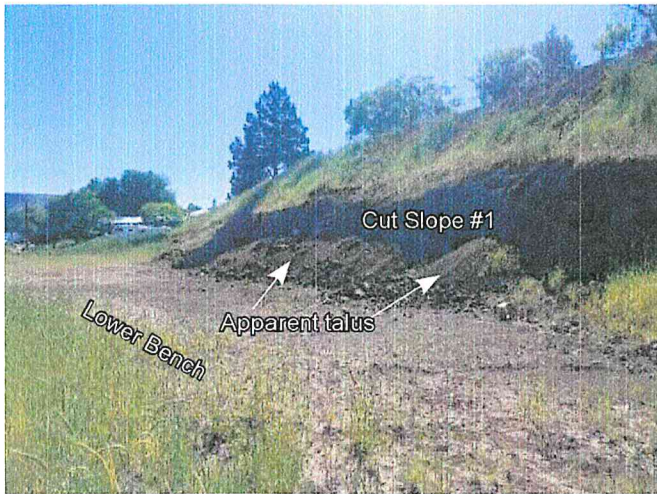
Photograph 9: Looking east at cut slope present at south side of lower bench of site.

- **Cut Slopes:** As indicated above, I observed two prominent cut slopes were present at the site. During today's visit, I did not see any indicators of imminent failures of the cut slopes present at the site. Apparent talus was present in areas along the lower cut slope, suggesting some erosion has occurred since the cut slope was created. I indicated to Nick that stabilization of the cut slopes (e.g. trimming them back, buttressing, or installing retaining walls) was advisable to provide assurance of long-term stability and reduce the potential of erosion/slumping.

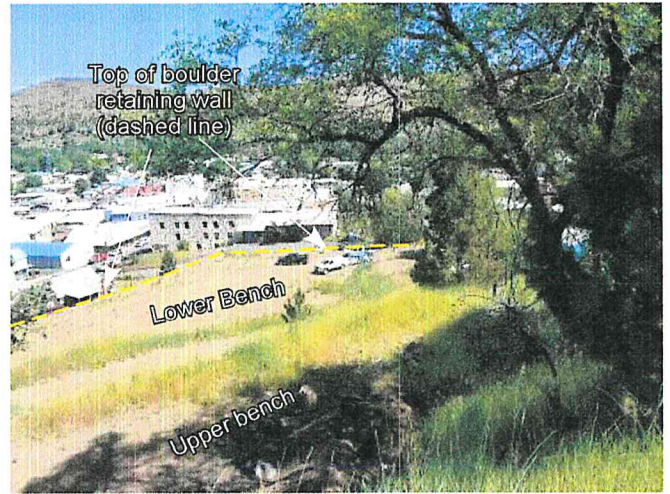
Photograph 10: Looking northeast from a point near the top of the upper cut slope (near City owned buildings)

- Near the east site entrance, an unimproved soil-covered road trended up the hillside towards a second (upper) bench. This bench was surfaced with soils and sparse grasses, was smaller in footprint compared with the lower bench, and appeared to have been created by a combination of cuts and fills. A second cut slope, designated as Cut Slope #2, was present along the south side of this bench and exhibited similar gradients as Cut Slope #1. Photograph 12 on the attached Figure 1 show conditions along this cut slope. The extent of fill materials on the second bench was difficult to ascertain, but was anticipated to be present in the northwestern portion of the bench. Photographs 10 through 12 on the attached Figure 1 show conditions within the upper bench.
