**Report of
Geological Hazard Assessment &
Preliminary Geotechnical Investigation
Strawberry View 80-Acre Subdivision
East of John Day, South of Highway 26
John Day, Oregon**

CGT Project Number G0602826

August 2, 2006

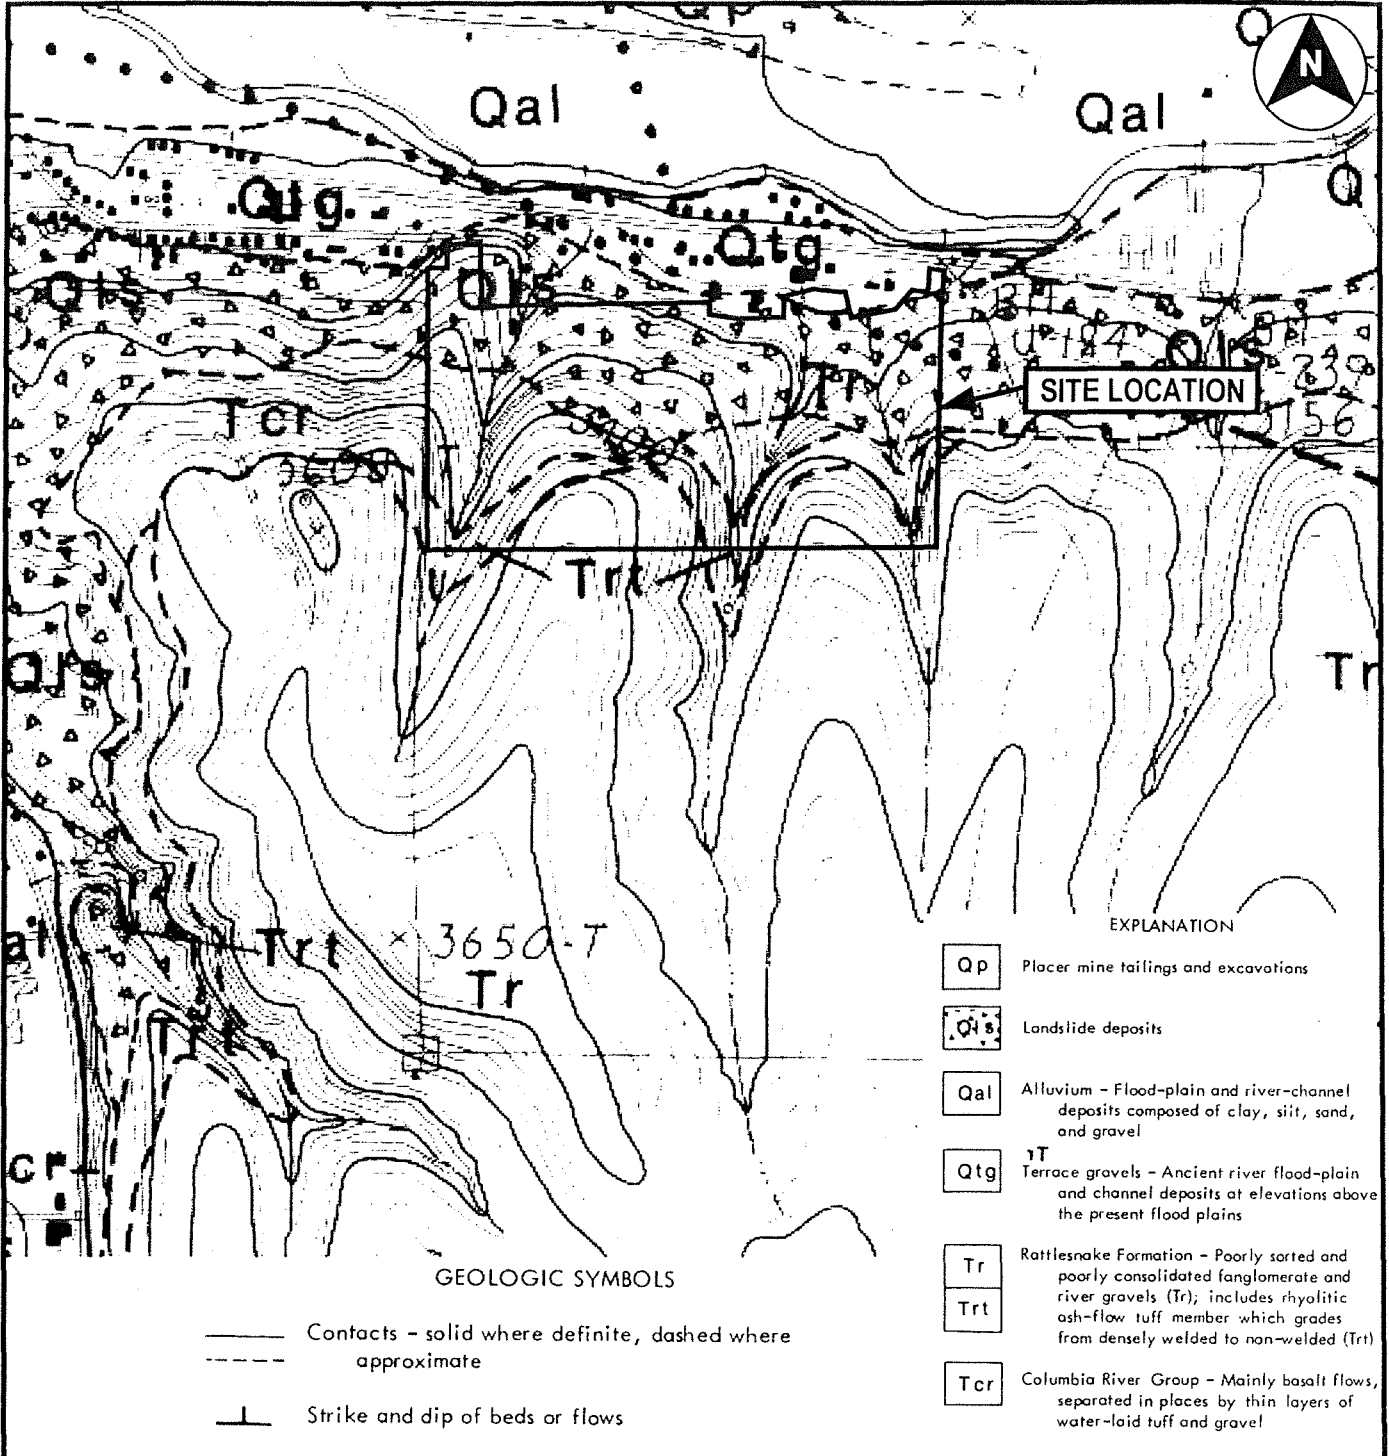
GEOLOGIC MAP

The geologic map shows areas of landslide deposits across the northern end of the site (Figure 4). This map unit includes ancient landslides, active landslides, and surficial failures. The report accompanying the geologic map indicates that hillside slopes in landslide terrain should be considered potentially unstable, and may be unsuitable for development in areas. The report indicates that the softer areas of the Rattlesnake Formation sediments are especially vulnerable to failure where overlain by the welded tuff member of the Rattlesnake Formation.

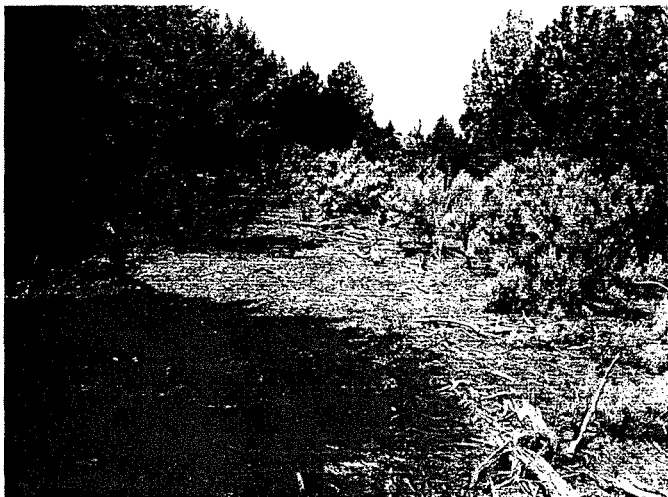
Photograph 3: Road grade along northern property boundary. Photo looking west.

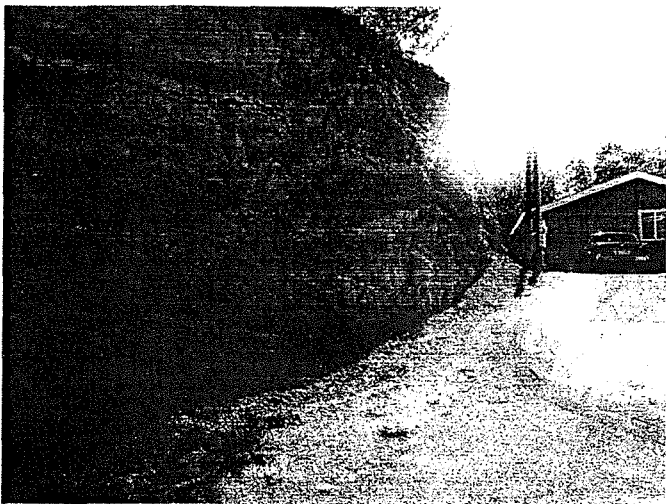
In addition to the test pits, we observed two cliff faces on the site. The first was located at the northwest corner of the site along Hillcrest Avenue, and consisted of well consolidated (hard) Rattlesnake Formation conglomerate. The cliff was maintaining a nearly vertical 20 to 25-foot high cut slope (Figure 6, Photograph 5), which had reportedly been cut more than 80 years ago. Houses were built at the base of this cut.

Photograph 5: Northwest corner of site along Hillcrest Avenue. Photo looking west.

The primary hazard along the existing cliffs on the site is rockfall. Therefore, CGT recommends, for preliminary planning, that existing slopes in the well consolidated conglomerate (northwest corner of site) be trimmed to no steeper than 1H:1V. We understand from the Site Plan (Figures 2 and 3) that no grading is planned within approximately 400 feet downslope from the rimrock welded tuff, which should offer a degree of protection from rockfall, depending upon the final grading of the slopes below the rimrock. Cut slopes should be provided with benches and appropriate toe-of-slope clearances to reduce the potential for damage from rockfall.

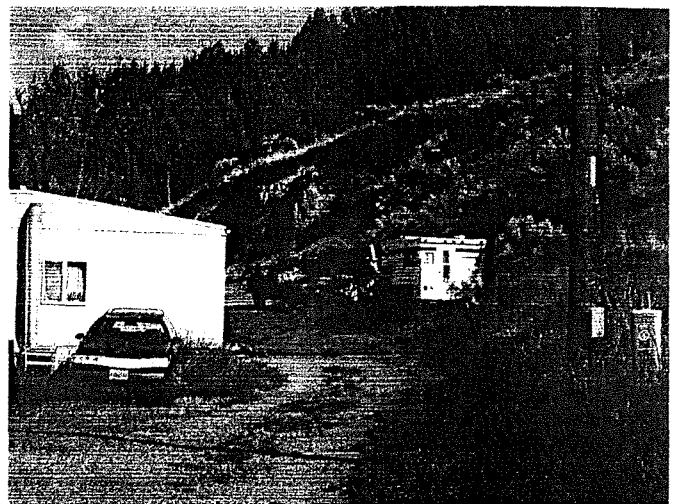
Photograph 6: Northwest corner of site along old road gradient. Photo looking southeast.
