IRON TRIANGLE PROPERTY 433 PATTERSON BRIDGE ROAD, JOHN DAY, OREGON 97845 PHASE I ENVIRONMENTAL SITE ASSESSMENT

Prepared for CITY OF JOHN DAY

> June 22, 2020 Project No. 1874.01.01

Prepared by Maul Foster & Alongi, Inc. 3140 NE Broadway Avenue, Portland, OR 97232

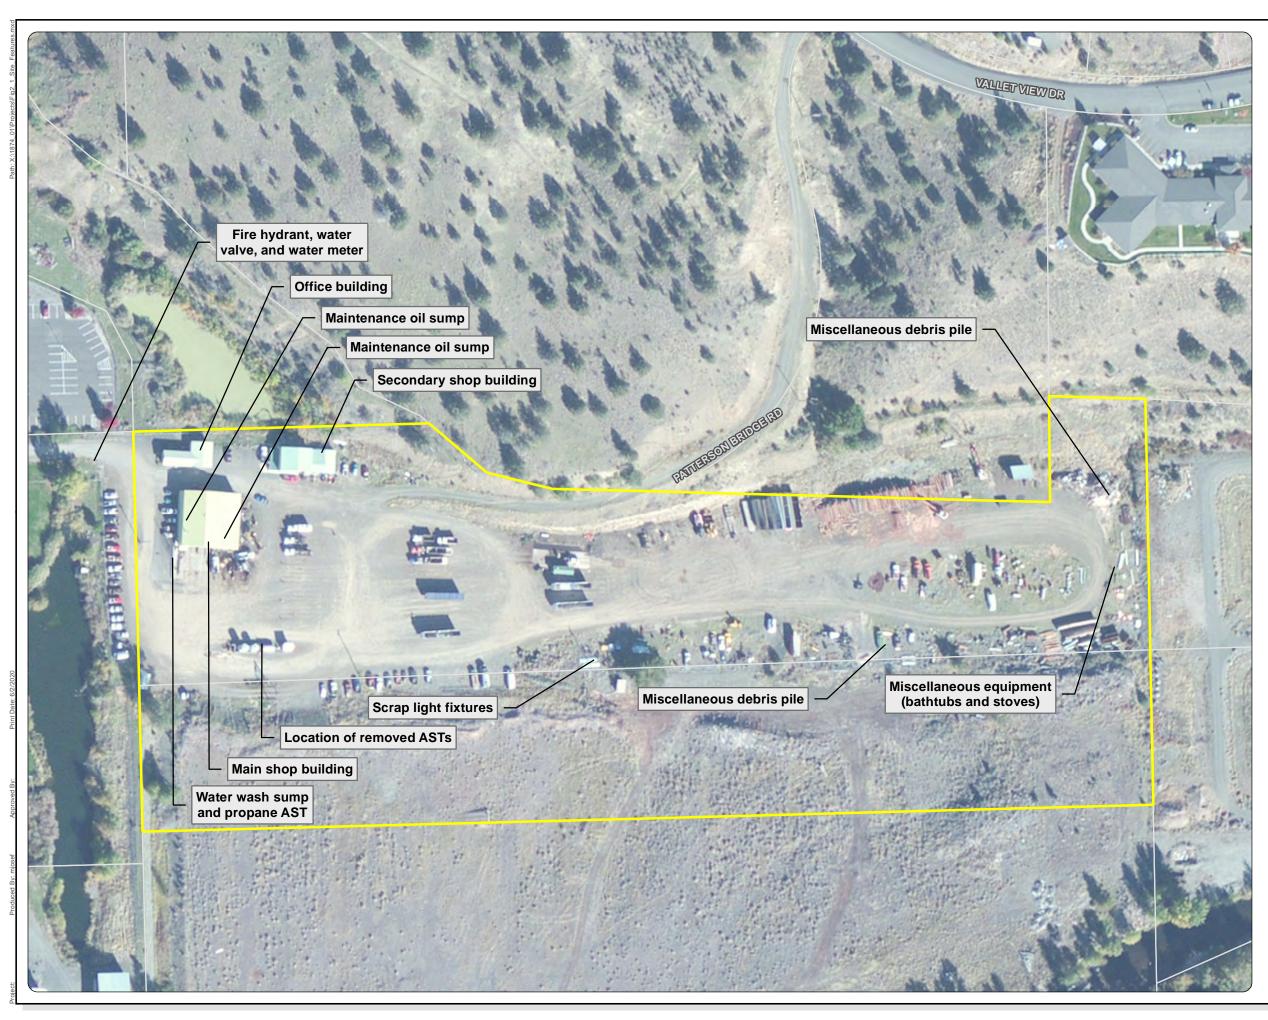
Figure 2-1 Site Features

The Property currently contains three structures: a main shop building, a secondary shop building, that is used for commercial sales, and an office building. The main shop building and the office building are vacant. While the Property was being vacated at the time of the site reconnaissance, the May 2019 appraisal report for the Property (Appendix C) shows an active equipment maintenance facility with equipment storage, three large fueling ASTs, drums and other tanks, stained soils, and miscellaneous material storage.

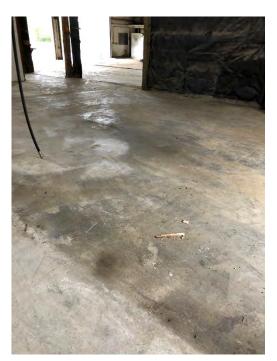
Photo No. 25.

Oil staining on the concrete inside the main shop building.

Oil staining in and around the main shop building. Aerial images and interviews suggest that the gravel/dirt surrounding the main shop building was previously oil stained. Oil stains were also observed on the concrete floor throughout the main shop building. The current Property owner indicated that the stained soil was occasionally cleaned up and removed from the Property. No cleanup records for the removal of oil-stained dirt/gravel or associated confirmation soil sampling were available. The historical oil staining constitutes a REC in connection with the Property.

It is recommended that a focused investigation be conducted to assess the potential presence of contaminants of concern associated with the identified RECs—concentrating specifically on the area around the main shop building where equipment maintenance was conducted and where the soil staining has occurred. Sampling and screening data to appropriate Oregon Department of Environmental Quality risk-based concentrations is recommended.

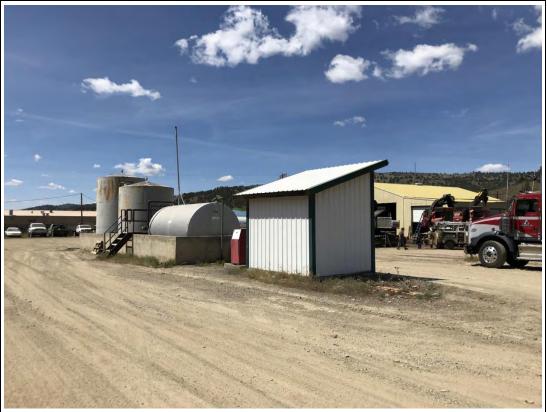
Above ground fueling station.

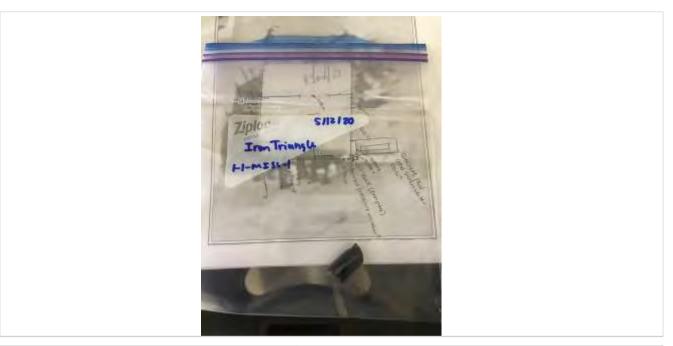
Sample ID:		Sample Type:	
1-1-MISC-1		MISC	
Misc Sample Material:	Gasket material		
Sample Location:		Detailed Sample Location:	
Window on built out office			
Sample Friable?:	Sample Condit	tion:	
No	Other		
Sample Color:		Sample Quantity:	XRF
		18 linear feet	
		Sample Photo:

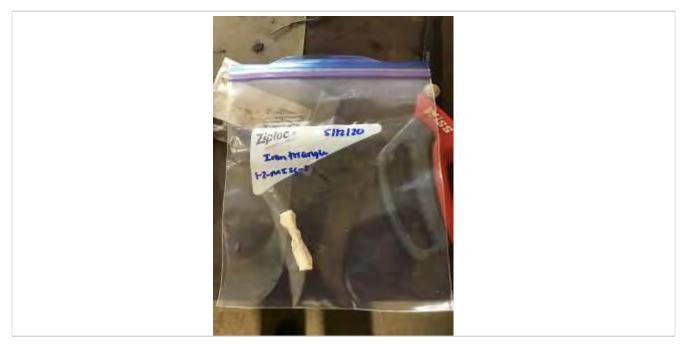
Sample ID:		Sample Type:	
1-2-MISC-2		MISC	
Misc Sample Material:	Drywall		
Sample Location:		Detailed Sample Location:	
Inside built out office			
Sample Friable?:	Sample Condition	on:	
No	Other		
Sample Color:		Sample Quantity:	XRF
		300 sq. ft.	
	S	ample Photo:

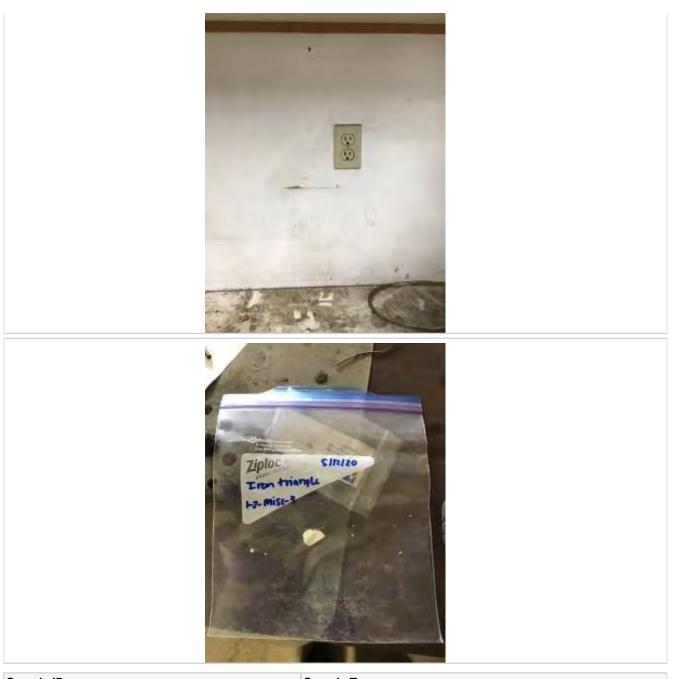
Sample ID:		Sample Type:	
1-2-MISC-3		MISC	
Misc Sample Material:	Drywall		
Sample Location:	Detailed Sample Location:		
Inside built out office			
Sample Friable?:	Sample Condition	on:	
No	Other		
Sample Color:		Sample Quantity:	XRF
		300 sq. ft.	
	S	ample Photo:

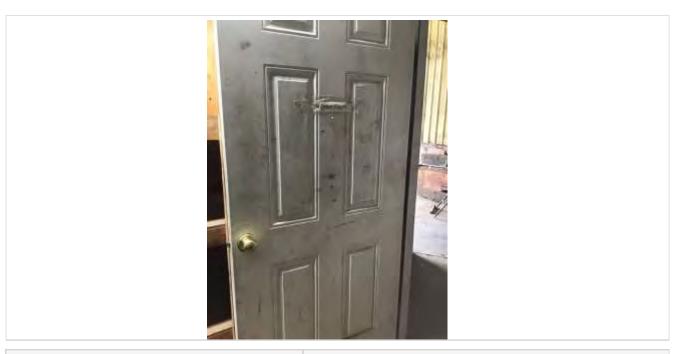
Sample ID:		Sample Type:	Sample Type:	
1-2-PB-4		PB		
Misc Sample Material:				
Sample Location:		Detailed Sample Location:		
Door to storage room under	stairs			
Sample Friable?:	Sample Co	ndition:		
Sample Color:		Sample Quantity:	XRF	
White		NA	Negative	
		Sample Photo:

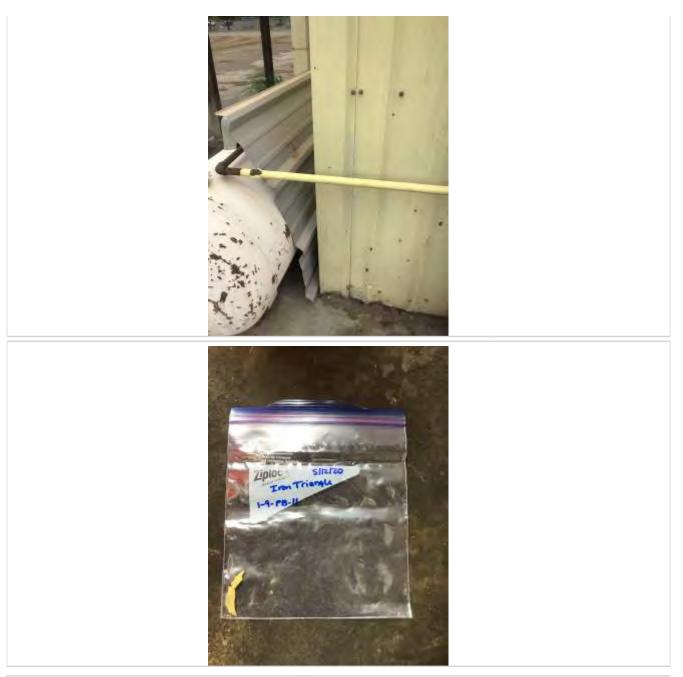
Sample ID: S		Sample Type:			
1-10-PB-12 F		PB	РВ		
Misc Sample Material:					
Sample Location:		Detailed Sample Location:			
SW corner exterior					
Sample Friable?: Sample Condit		ion:			
Sample Color:		Sample Quantity:	XRF		
Light yellow		NA	Negative		
	Ś	Sample Photo:
