**Report of
Geological Hazard Assessment &
Preliminary Geotechnical Investigation
Strawberry View 80-Acre Subdivision
East of John Day, South of Highway 26
John Day, Oregon**

CGT Project Number G0602826

August 2, 2006

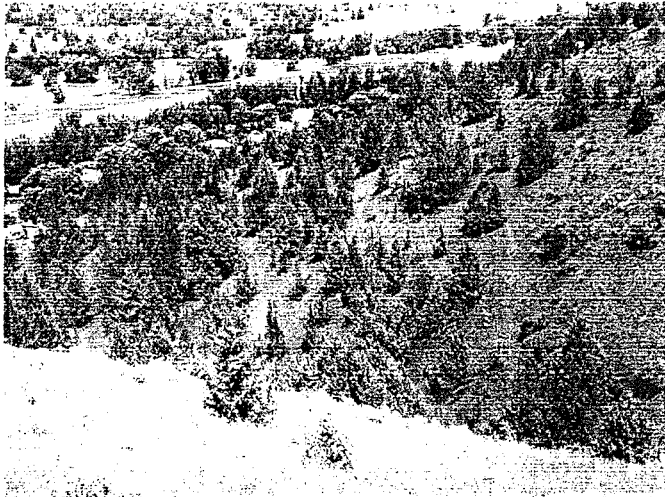
The northern property boundary was typically located approximately 200 to 400 feet south of Highway 26. The area north of the northern site boundary and south of Highway 26 was occupied by single-family residences and two churches (Figure 5, Photograph 1). The property abutted Highway 26 for approximately 75 feet in the extreme northeast corner of the site, which will provide the primary access to the subdivision. The properties located east, west, and south

Photograph 1: Site with offsite residences in distance. Photo looking northeast.

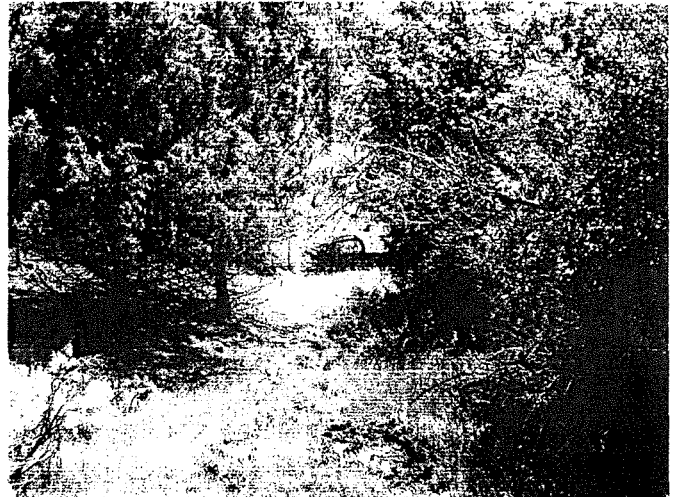
Photograph 2: Stream located near central portion of site. Photo looking south.
